Iron viaduct repaired with steel

A crucial piece of infrastructure serving the Hampshire to Isle of Wight ferry service has been fully restored and refurbished with new steelwork.

Lymington Viaduct, Hampshire

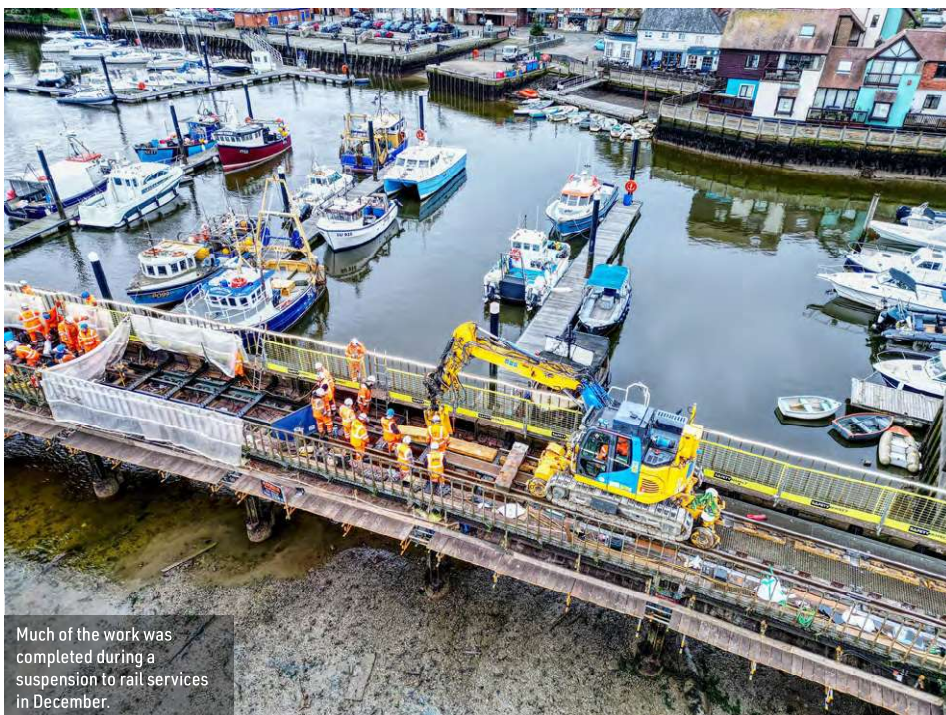
Much of the work was completed during a suspension to rail services in December.

The steelwork was initially delivered to a nearby quayside and transported by boat to a storage pontoon. From there, a small spider crane moved individual items from the pontoon to the viaduct, where they were welded or bolted into place. This work was undertaken after the existing rail bearers had been gas-cut out and removed via a gantry.

In total, FTE removed and replaced 54 of the viaduct's 82 iron rail bearers. The new steel bearers were fabricated from plate with underslung bolted angles to tie them together. They were delivered to site in 1.4m-long lengths, which weighed approximately 140kg each.

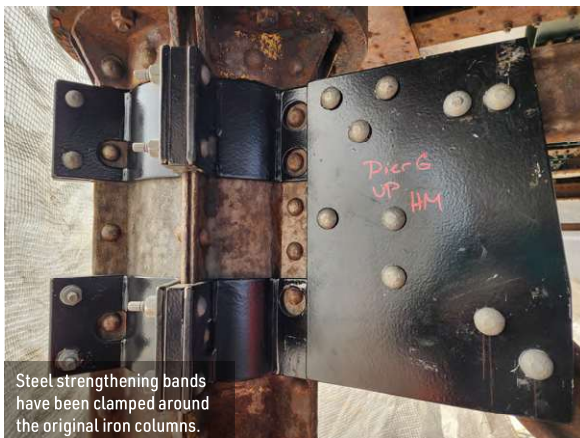
Steel strengthening bands have been clamped around the original iron columns.

The majority of FTE's work involved the repair and replacement of these iron rail bearers, but some cross members and the viaduct's supporting

columns also needed strengthening with steel plates, bands and bracings.

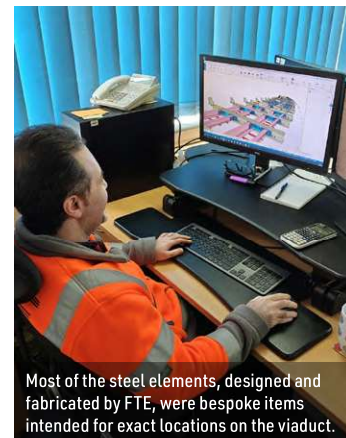
Most of the steel elements, designed and fabricated by FTE, were bespoke items intended for exact locations on the viaduct.

Most of the elements were bespoke and had to be installed at exact locations, as the bridge is slightly curved on plan. Working over water and on a site with no room for materials to be stored presented another challenge to the team.
